West Virginia Chemical Leak
Etowah, Kanawha County, West Virginia
TDD No TL01-14-01-001

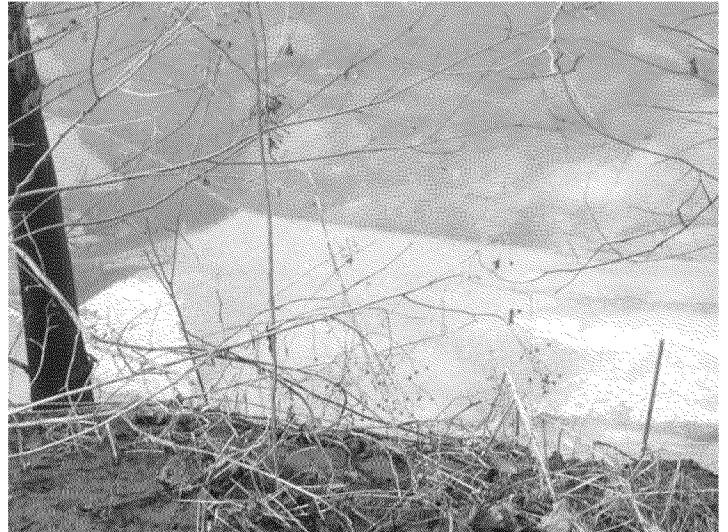
Photo No. IMG_1056; Taken on 01/10/14 at 13:51 hours by START GN. Ice at river edge with what appears to be product trapped under it.

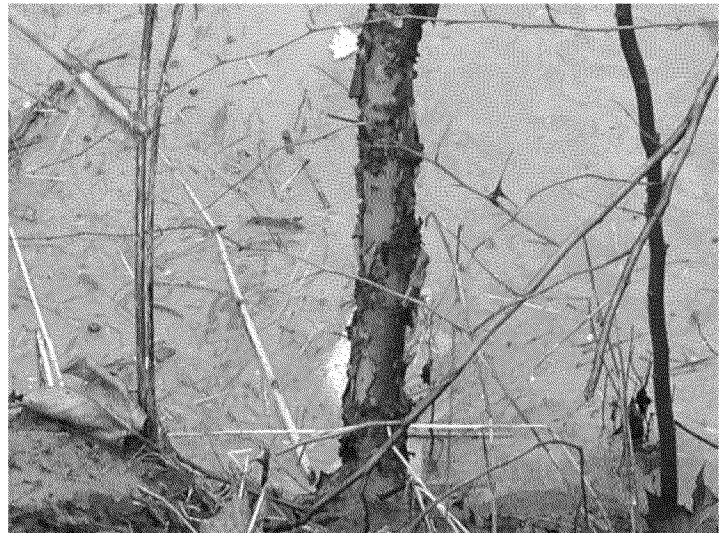
Photo No. IMG_1100; Taken on 01/11/14 at 12:27 hours by START GN. Debris and MCHM product collected in river boom in Elk River.

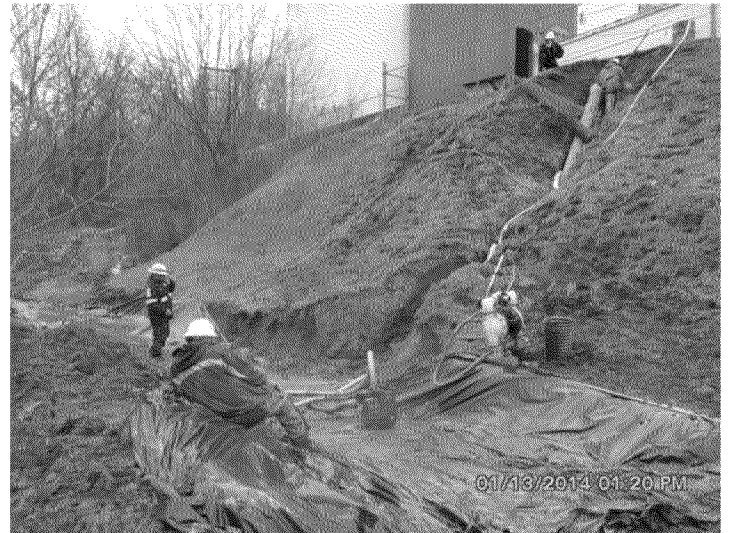
Photo No. SAM_1601; Taken on 01/13/14 at 13:20 hours by
START MD. Cutting of faulty storm drain

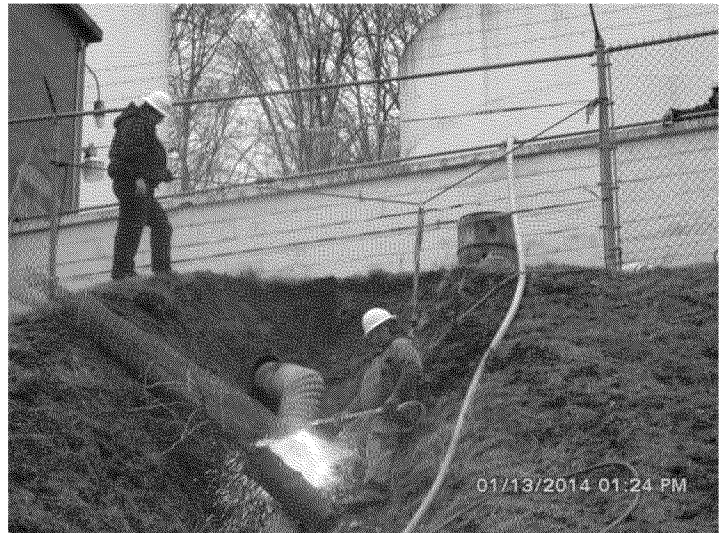
Photo No. SAM_1605; Taken on 01/13/14 at 13:24 hours by START MD. Cutting of faulty storm drain

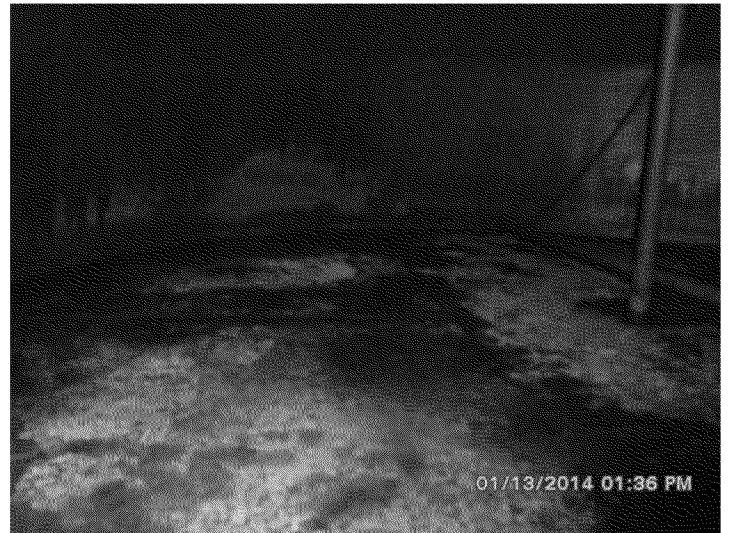
Photo No. SAM_1609; Taken on 01/13/14 at 13:36 hours by START MD. Inside of breached tank

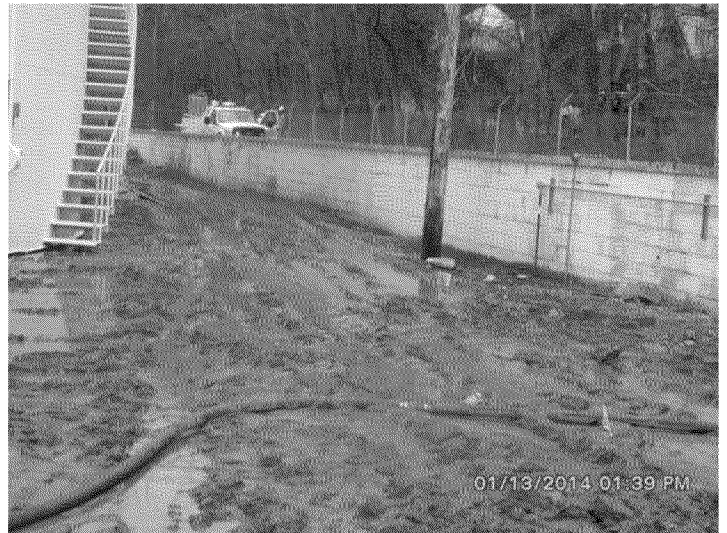
Photo No. SAM_1618; Taken on 01/13/14 at 13:39 hours by START MD. Product in exploratory pit under edge of breached tank

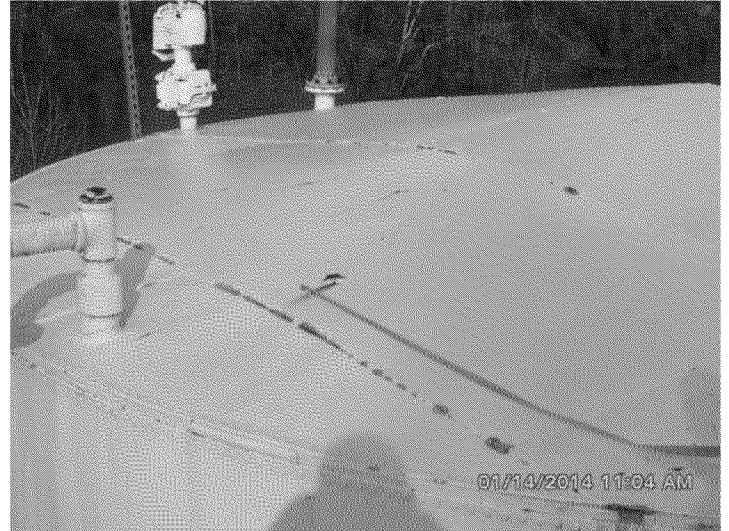
Photo No. SAM_1665; Taken on 01/14/14 at 11:04 hours by START MG. CSB investigator point out rust spot on top of tank

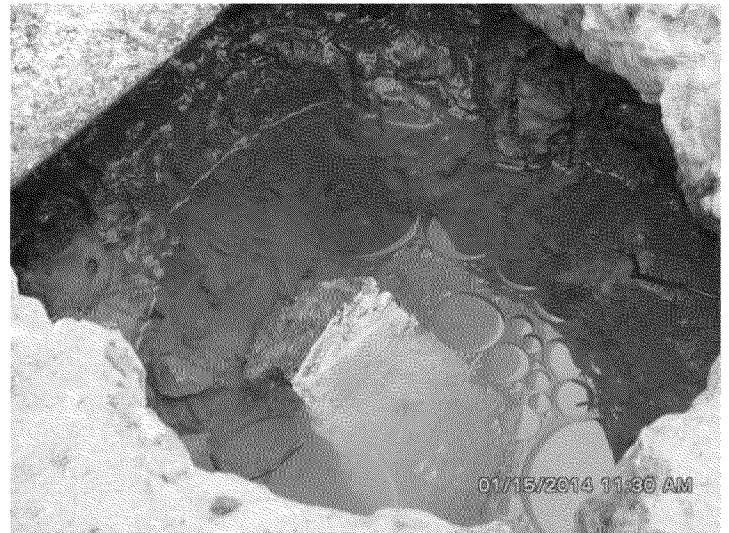
Photo No. SAM_1733; Taken on 01/15/14 at 11:35 hours by
START MG. Product in exploratory pit

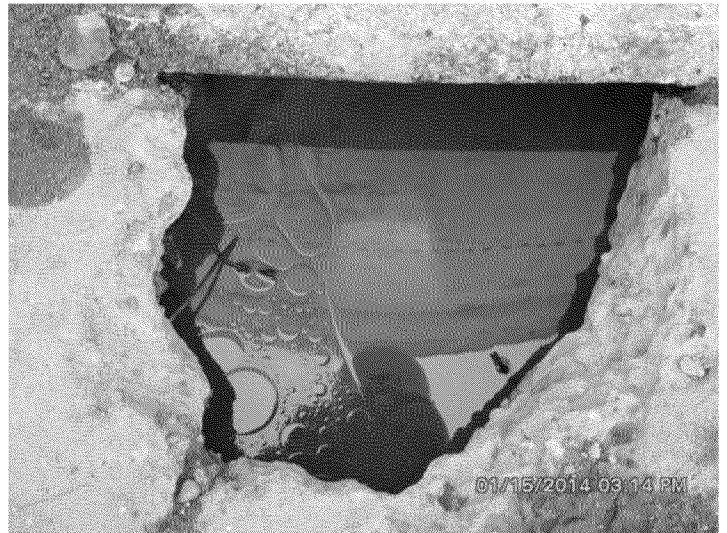
Photo No. SAM_1753; Taken on 01/15/14 at 15:14 hours by START MG. Product still surfacing in exploratory under edge of the tank

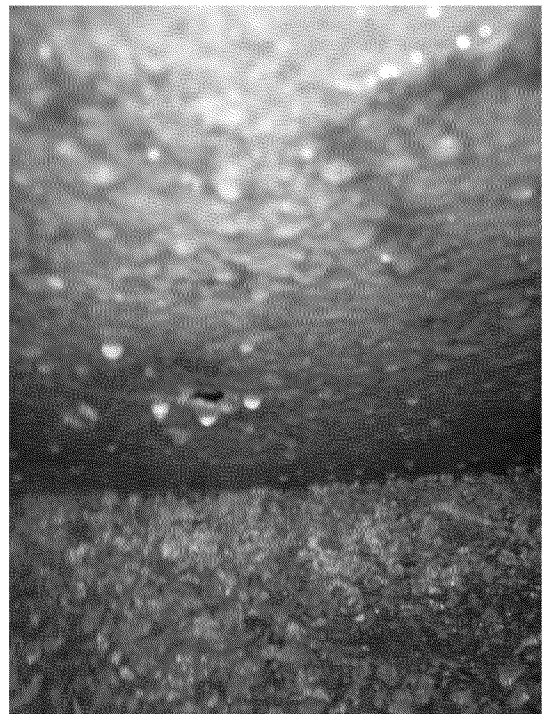
Photo No. IMG_1156; Taken on 01/17/14 at 9:33 hours by
START GN. A view of the hole in the bottom of the tank, from
under the tank.

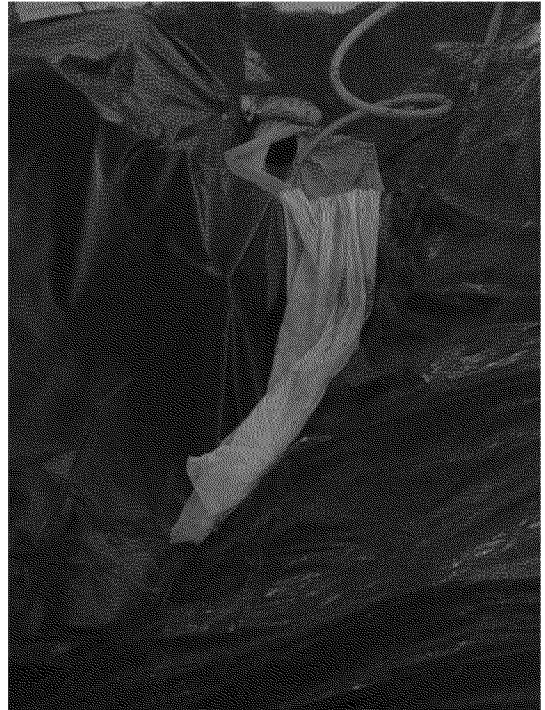
Photo No. IMG_1164; Taken on 01/17/14 at 10:56 hours by START GN. Water discharging from storm water culvert from under tank farm.

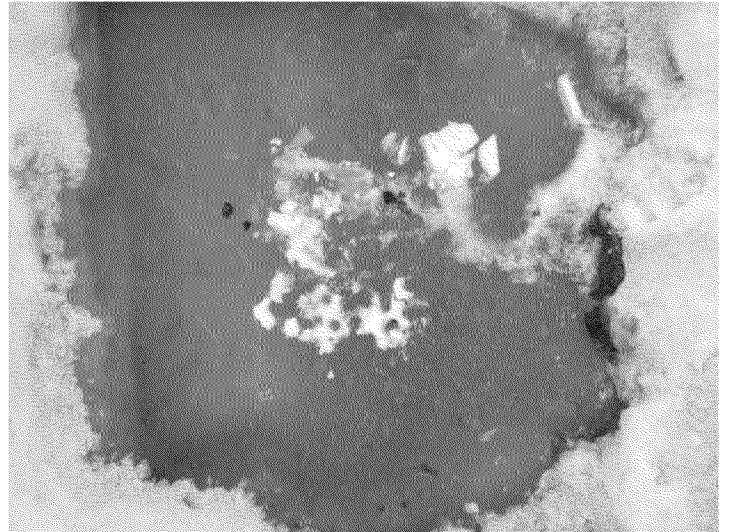
Photo No. IMG_1217; Taken on 01/22/14 at 15:29 hours by START GN. Product on top of ice in hole by tank where release occurred.
